# Richmond Refinery LPS Bulletin-Reliability FCC- Pit Stop – Deethanizer Bundle Leak (1/8/2012)

**IMPACT ERM**  
**Loss ID#30449**

FCC Plant  
Cracking Division

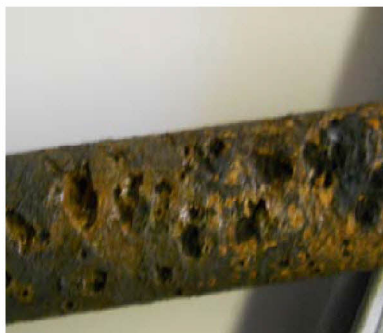
Severe pitting on OD of tubes

- 1) A single tube was found to be leaking during the inspection with severe pitting on OD of tubes. This corrosion had never been seen on the bundle before.
- 2) The original design of the exchanger allows areas of the bundle and shell to have stagnant or low flow areas. Stagnant or minimal flow regimes in the bundle will cause corrosion due to the ammonium bisulfide. This low flow condition was identified in 1993 during original analysis of exchanger and nothing was done to rectify the issue.
- 3) From January 2011 to January 2012, there were more instances of high chloride feed to the FCC than had been seen in the previous five year run from 2005 to 2010.
- 4) During high chloride feed events, excess water was found in V-121 (depentanizer reflux drum) downstream of E-142A. This indicated more water was present in the exchanger.

- 1) Excess water coupled with higher chlorides in areas already susceptible to ammonium bisulfide corrosion caused accelerated corrosion to occur in the bundle resulting in a failure.

- 1) Inspect other areas that maybe at risk for accelerated corrosion due to ammonium bisulfide and the increase in chlorides with water.
- 2) Redesign E-142A to eliminate low flow areas in the exchanger and install a new unit at earliest opportunity or by 2015 FCC Major startup.

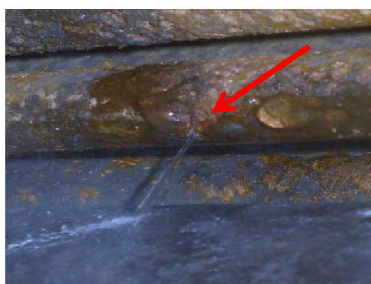
Leaking tube identified during hydrotesting of the bundle
